TELEVISION

AND HOME ELECTRONICS REPAIR

DECEMBER 2001 £3.00

Panasonic's Euro-5 chassis featuring 100Hz scanning

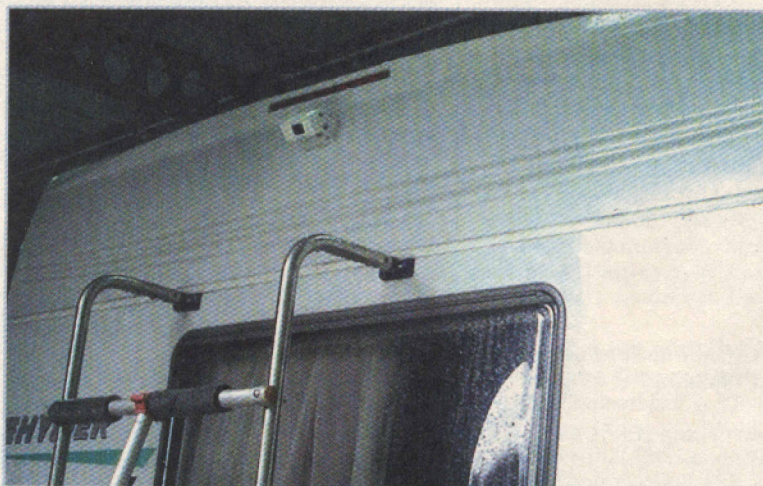
*Photos 1 and 2:
Rear-view camera
mounted towards
the top centre at
the rear of a
motor home.*

A job I'm often asked to do is to fit a rear-mounted camera system to a motor home so that the driver can see what's behind when reversing. The display consists of a small 5in. monitor on the dashboard. It's not a particularly difficult job, but it can take a whole day. Make sure that your quotation takes this into account.

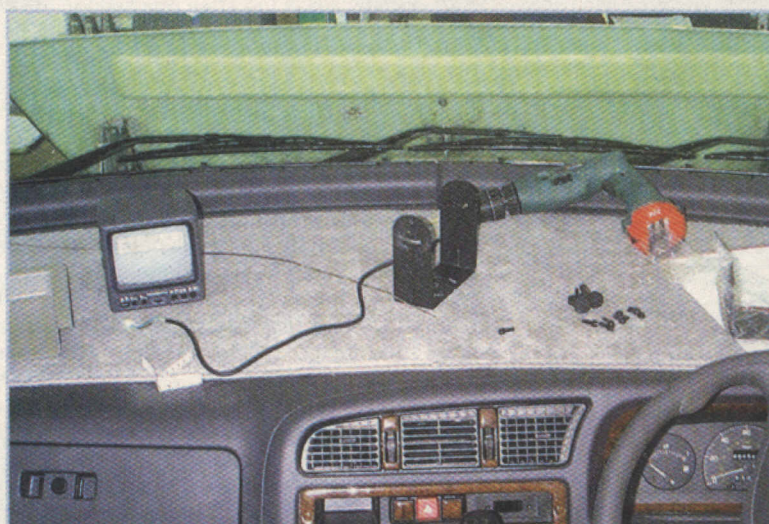
Photo 4: Assembling the 5in. monitor on the dashboard.

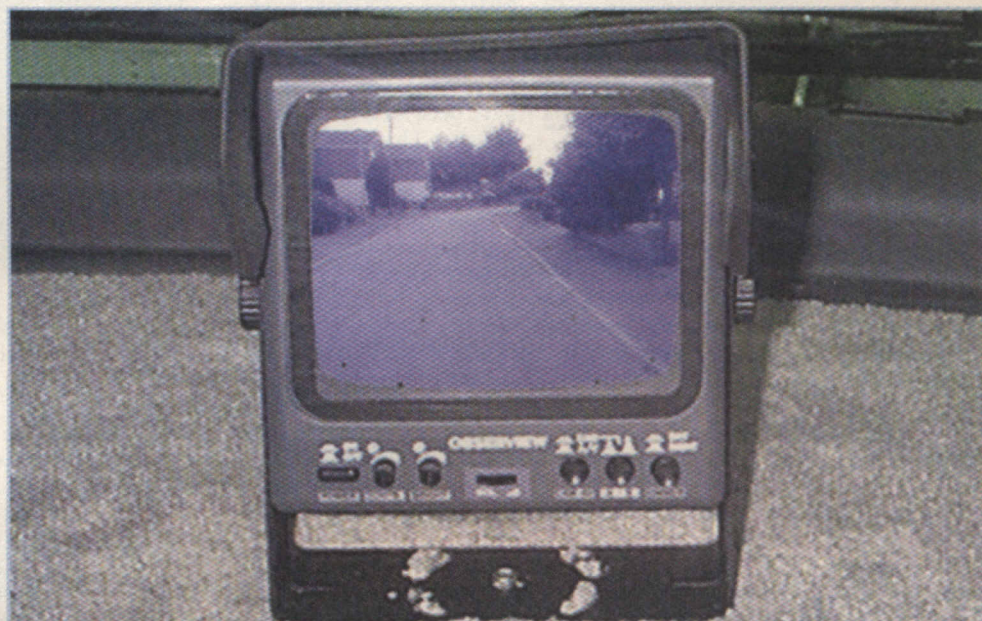
Photo 5: The monitor in use as a rear-view mirror.

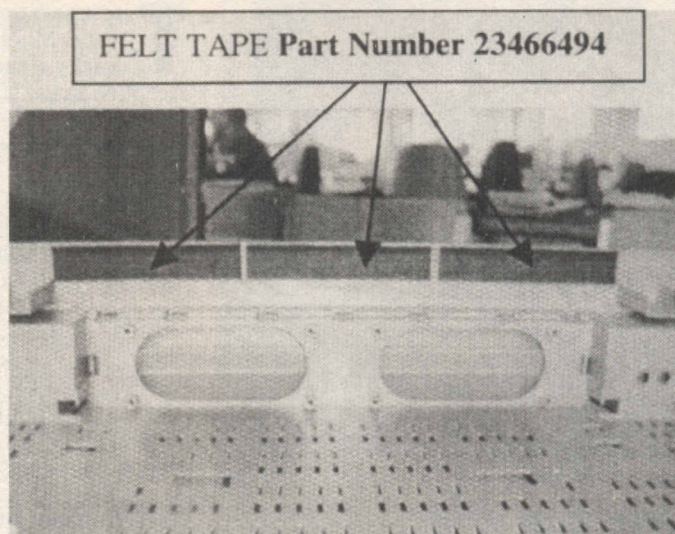
Fig. 2: Where to fit the felt tape in Model 32WD98B/G to prevent centre speaker buzz.

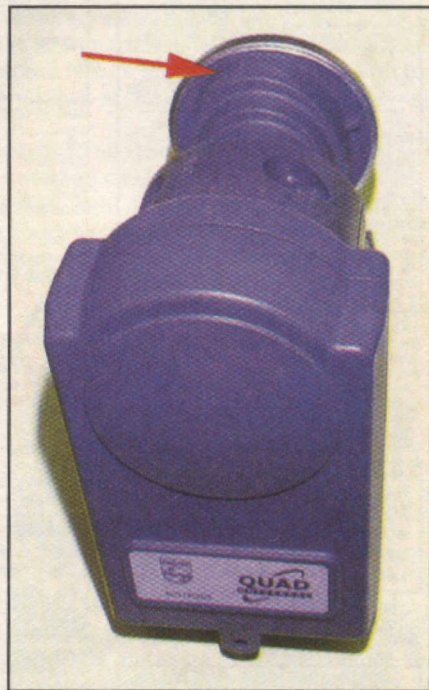
Photo 1: The Philips SC519QS/S LNB. The red arrow points to the oval scalar rings, which match the shape of the Sky Minidish.

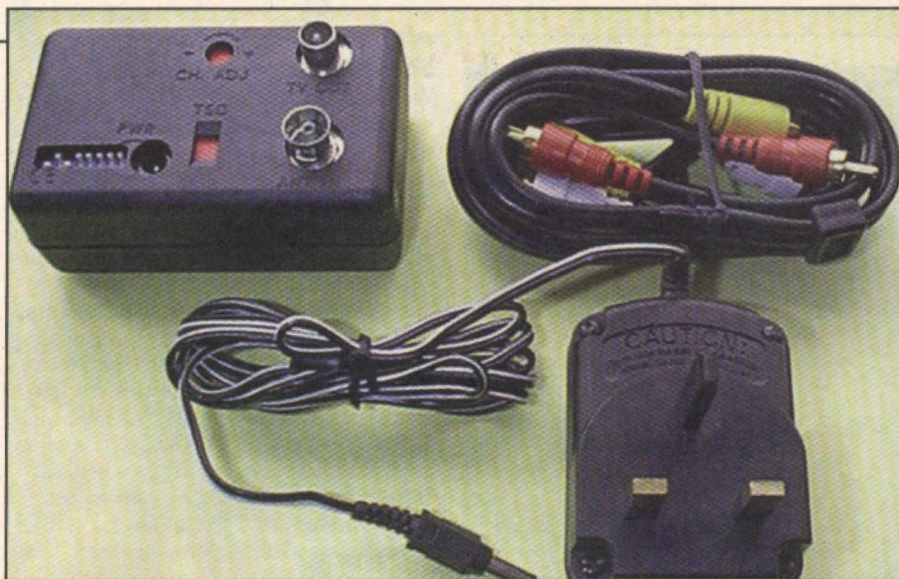
Photo 2: The SatCure RF modulator, which accepts baseband video and sound from a digibox's scart socket and provides an output on any, selectable UHF TV channel.

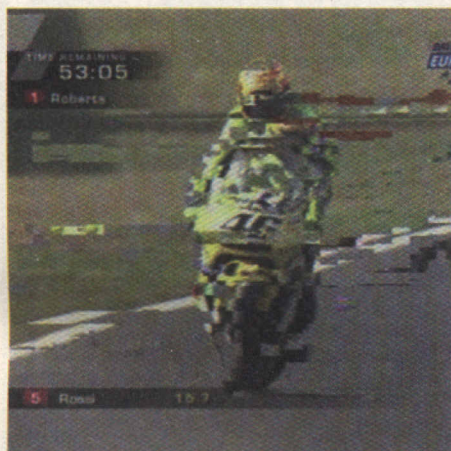
Photo 3: Pixelation effect produced when the carrier-to-noise ratio falls to 4-5dB.

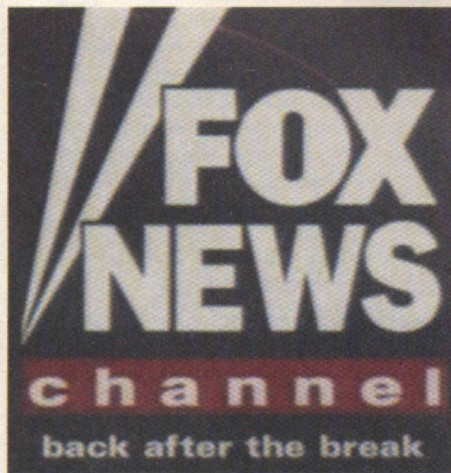
Photo 4: Channel identification card used to block US advertisement breaks with Fox News.

The US Fox News channel has no EPG number at present and has to be added as an 'extra channel' using the 'add channels' menu. It's also available at 19.2°E (Astra 1) in unencrypted analogue form. Tune to 11.435GHz V (the old Sky MovieMax analogue transponder). A channel identification card is used to block US advertisement breaks, see Photo 4.
